# GLENFIELD INVICTA REFURBISHES VALVES AT DOLGARROG HYDRO-ELECTRIC POWER STATION

# Case Study

## Dams, Reservoirs & Hydropower

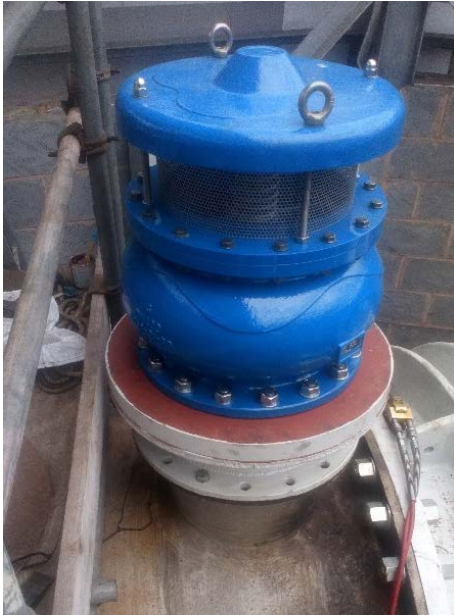
Anti-vacuum air valve

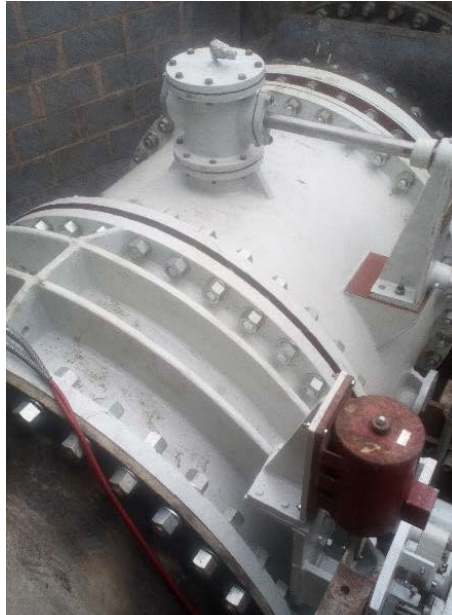
Refurbished valve and operating arrangement

“The butterfly valve is auto self-closing. There is a paddle downstream linked to the valve via hydraulic pistons. When water velocity reaches a certain speed, the paddle triggers the valve’s closing mechanism. Glenfield Invicta engineers replaced the hydraulic pistons but managed to refurbish and reuse the existing hydraulic unit. The shaft of the butterfly valve was also replaced.”

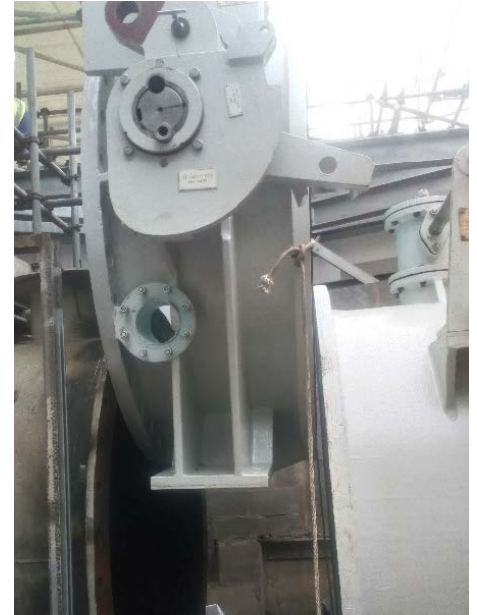
Installation of refurbished butterfly valve
