Baltimore Tunnel, Strathblane

Air Valve Refurbishment

Case Study

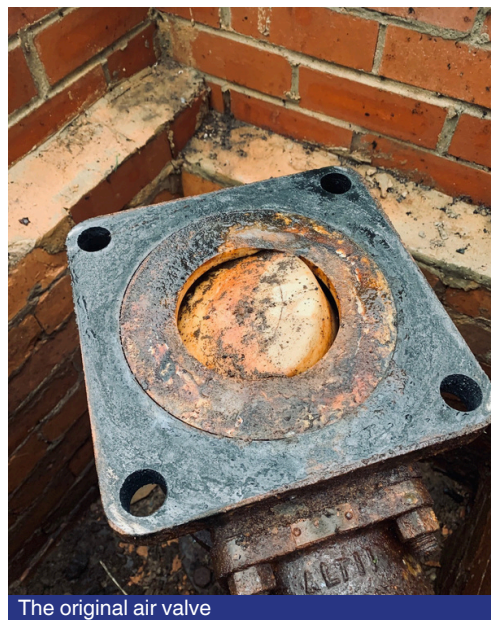
The original air valve

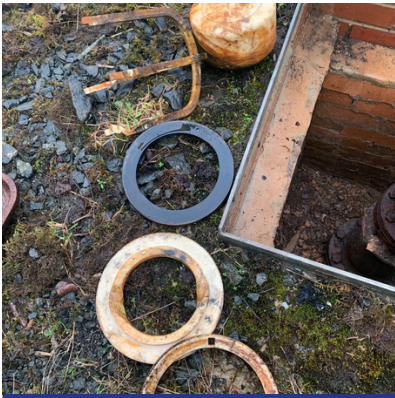
The original air valve

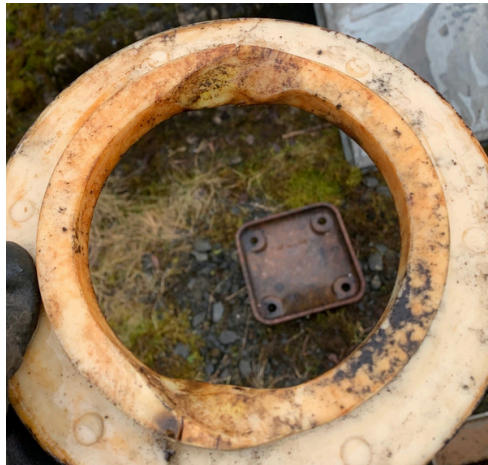
The original air valve

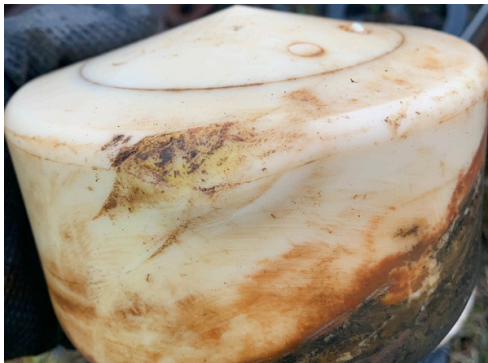
The original air valve

“From the initial inspection of the valve in situ, it was clear that the cast iron body was in decent condition albeit extremely weathered from decades in a chamber so we discussed with George Leslie the option of refurbishing the valve rather than replacing.

Once the valve was removed from its position safely and taken to the Glenfield Invicta Kilmarnock facility, the internal components of the air valve were carefully extracted. Advanced shot blasting techniques were used to remove old paint, rust, and other contaminants from the air valve surface, achieving a clean and smooth surface ready for new coatings.

A full new set of internal components designed to enhance the performance and longevity of the air valve were installed, using high-quality materials to ensure durability and reliability. High-performance paint coatings were applied both internally and externally, selected for their resistance to corrosion and ability to withstand the environmental conditions.

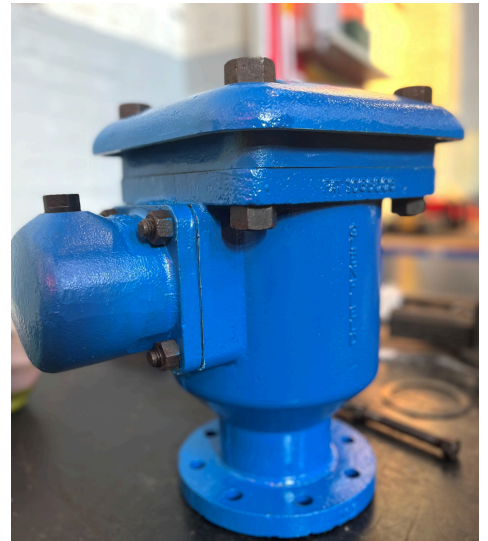
The refurbished air valve
